# DRAIN 247

## CCTV Inspection Report

44 Clarendon Road

### **CONDITION SURVEY REPORT**

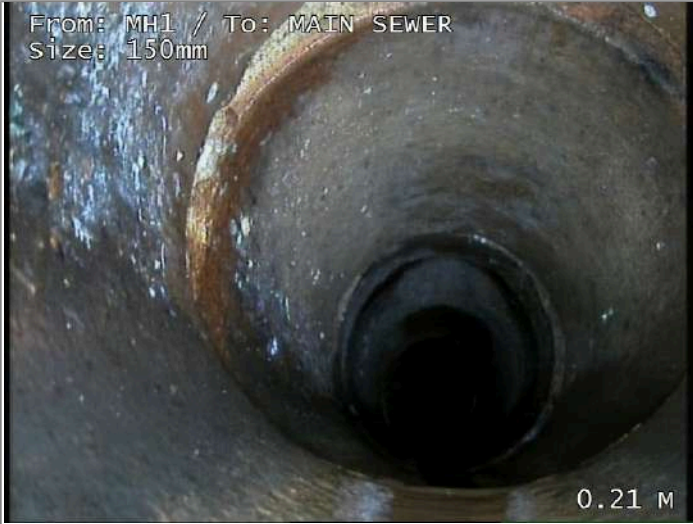
| Position | Code | Description | Photo | Type/Grade |
|---|---|---|---|---|
| 0.21 | JD | Joint displaced 15mm | 14440394 | Structural / 3 |

| Job Number<br><b>JB010XX</b> | Surveyed by (Operator)<br>TG/CM | Base Unit<br><b>CAMERA UNIT</b> | Date<br>17/03/2026 |
|---|---|---|---|
| <p>From: MH1 / To: MAIN SEWER<br/>Size: 150mm</p> <p>0.21 M</p> <p>Joint displaced 15mm</p> | | | |

1. **Intensive High-Pressure Water Jetting:** To remove the settled hard deposits and ensuring the system is fully cleared and preventing future blockages.
2. **Structural Patch Lining:** To seal all the the displaced joints identified during the survey. This repair will help extend the lifespan of the existing system and ensure its continued structural integrity.
3. **Post-Cleaning & Repair CCTV Survey:** After completing the intensive cleaning and structural patch lining, we suggest conducting another CCTV survey to thoroughly assess the condition of the pipework.

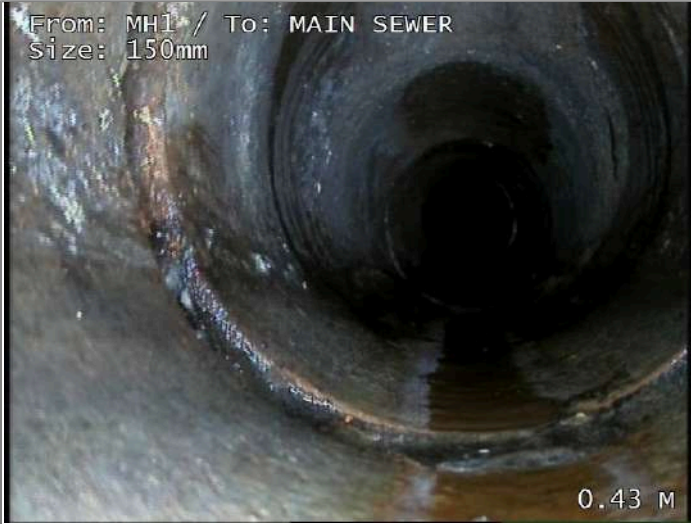
| Position | Code | Description | Photo | Type/Grade |
|---|---|---|---|---|
| 0.43 | JD | Joint displaced 15mm | 14440395 | Structural / 3 |

| Job Number<br><b>JB010XX</b> | Surveyed by (Operator)<br>TG/CM | Base Unit<br><b>CAMERA UNIT</b> | Date<br>17/03/2026 |
|---|---|---|---|
| <p>From: MH1 / To: MAIN SEWER<br/>Size: 150mm</p> <p>0.43 M</p> <p>Joint displaced 15mm</p> | | | |

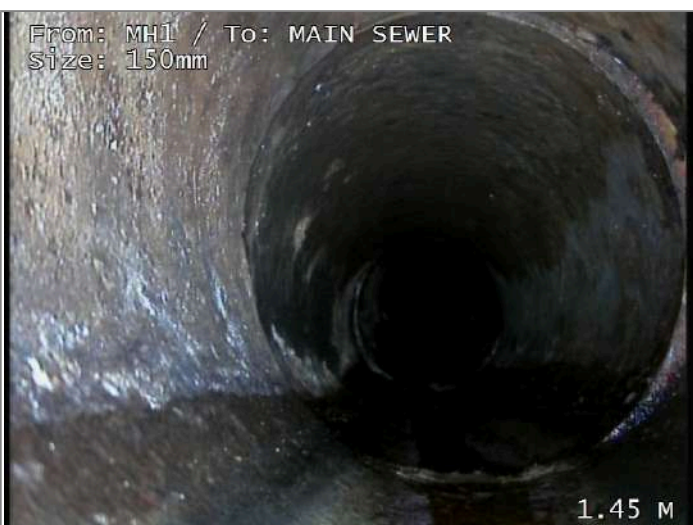
| Position | Code | Description | Photo | Type/Grade |
|---|---|---|---|---|
| 1.45 | JD | Joint displaced 15mm | 14440396 | Structural / 3 |

| Job Number<br><b>JB010XX</b> | Surveyed by (Operator)<br>TG/CM | Base Unit<br><b>CAMERA UNIT</b> | Date<br>17/03/2026 |
|---|---|---|---|
| <p>From: MH1 / To: MAIN SEWER<br/>Size: 150mm</p> <p>1.45 M</p> <p>Joint displaced 15mm</p> | | | |

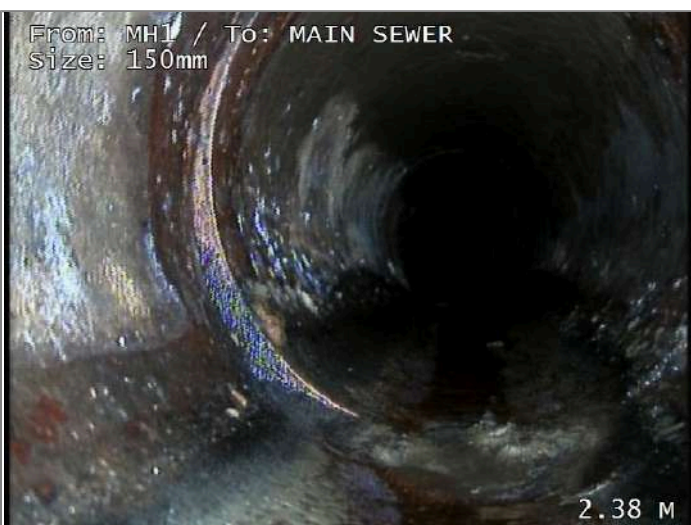
| Position | Code | Description | Photo | Type/Grade |
|---|---|---|---|---|
| 2.38 | JD | Joint displaced 15mm | 14440397 | Structural / 3 |

| Job Number<br><b>JB010XX</b> | Surveyed by (Operator)<br>TG/CM | Base Unit<br><b>CAMERA UNIT</b> | Date<br>17/03/2026 |
|---|---|---|---|
| <p>From: MH1 / To: MAIN SEWER<br/>Size: 150mm</p> <p>2.38 M</p> <p>Joint displaced 15mm</p> | | | |

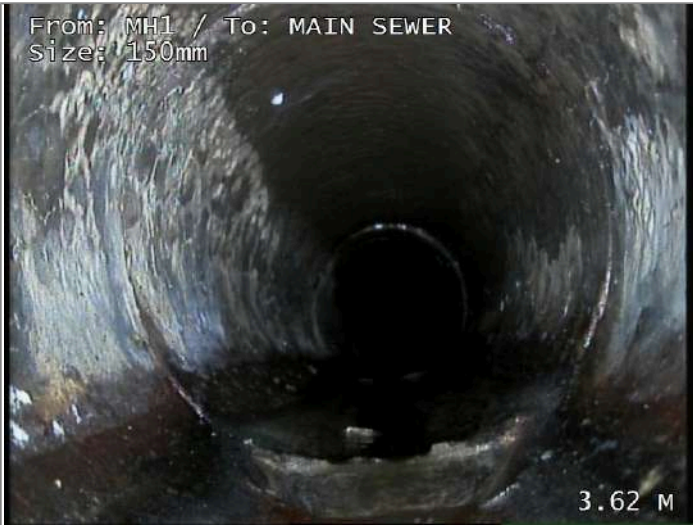
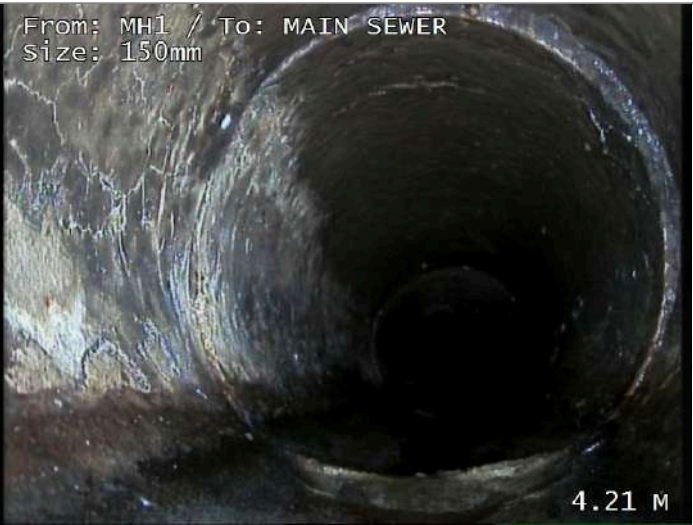
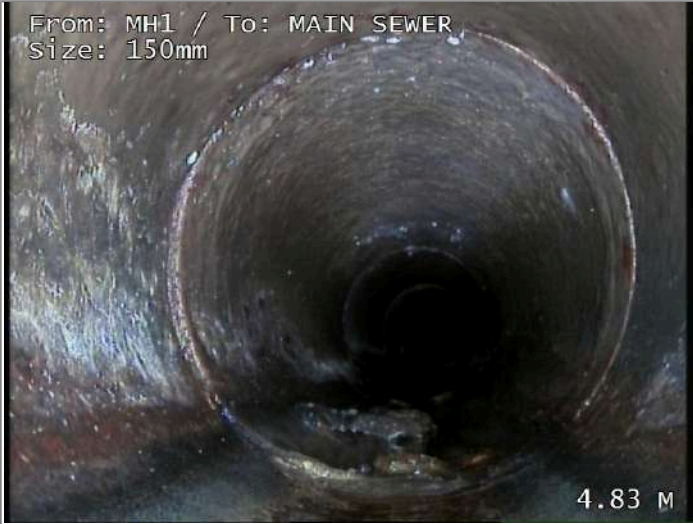
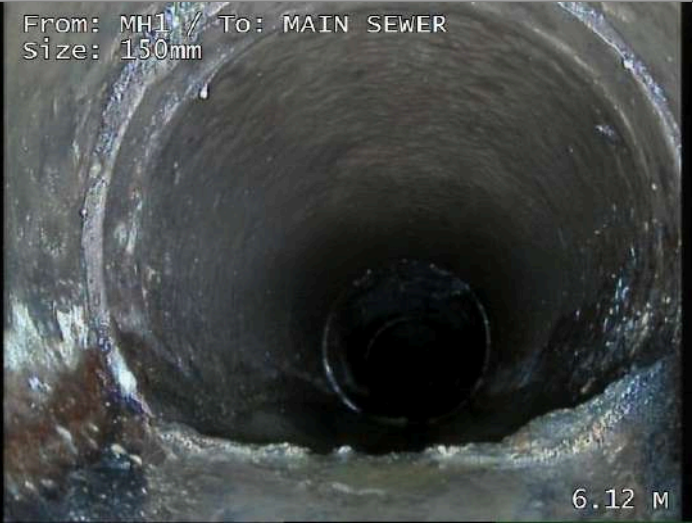
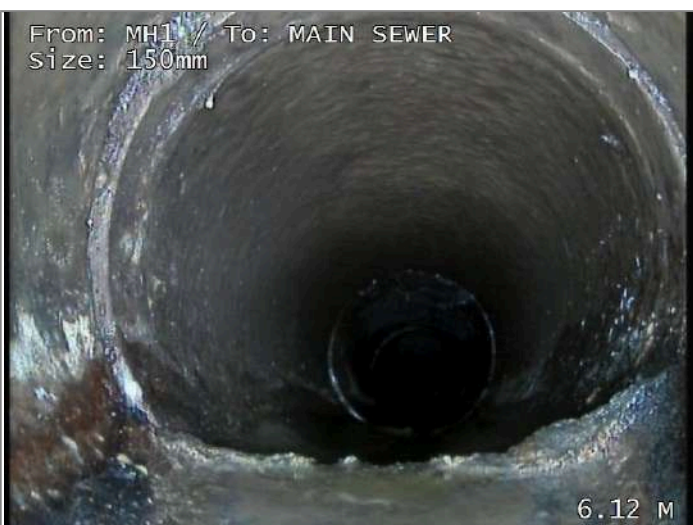
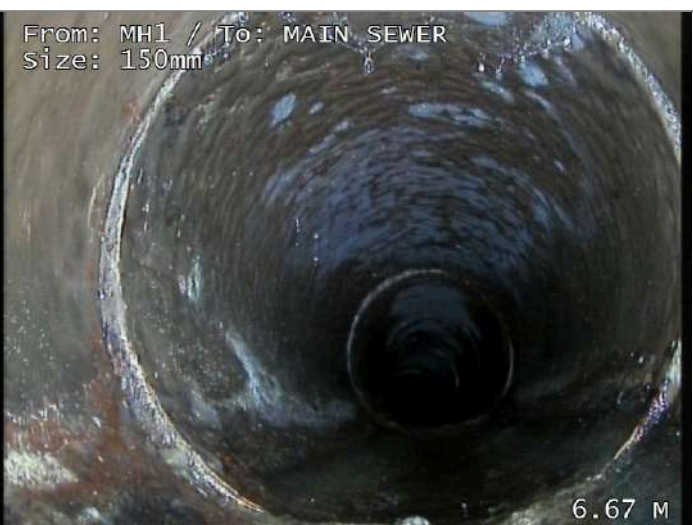
| Job Number<br><b>JB010XX</b> | Surveyed by (Operator)<br><b>TG/CM</b> | Base Unit<br><b>CAMERA UNIT</b> | Date<br><b>17/03/2026</b> |
|---|---|---|---|
| <div> <div> <p>From: MH1 / To: MAIN SEWER<br/>Size: 150mm</p> <p>3.62 M</p> <p>Settled deposits fine 10% cross-sectional area loss, at joint</p> </div> <div> <p>From: MH1 / To: MAIN SEWER<br/>Size: 150mm</p> <p>4.21 M</p> <p>Joint displaced 15mm</p> </div> </div> | | | |
| <div> <div> <p>From: MH1 / To: MAIN SEWER<br/>Size: 150mm</p> <p>4.83 M</p> <p>Settled deposits fine 10% cross-sectional area loss, at joint</p> </div> <div> <p>From: MH1 / To: MAIN SEWER<br/>Size: 150mm</p> <p>6.12 M</p> <p>Joint displaced 15mm</p> </div> </div> | | | |
| <div> <div> <p>From: MH1 / To: MAIN SEWER<br/>Size: 150mm</p> <p>6.12 M</p> <p>Settled deposits fine 10% cross-sectional area loss, at joint</p> </div> <div> <p>From: MH1 / To: MAIN SEWER<br/>Size: 150mm</p> <p>6.67 M</p> <p>Joint displaced 15mm</p> </div> </div> | | | |

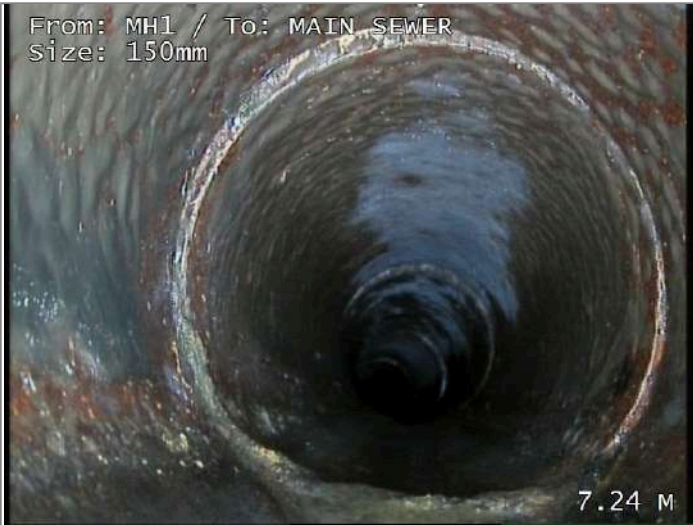
| Job Number<br><b>JB010XX</b> | Surveyed by (Operator)<br><b>TG/CM</b> | Base Unit<br><b>CAMERA UNIT</b> | Date<br><b>17/03/2026</b> |
|---|---|---|---|
| <div> <div> From: MH1 / To: MAIN SEWER<br/>Size: 150mm </div> 7.24 M </div> <div>Joint displaced 15mm</div> | | | |

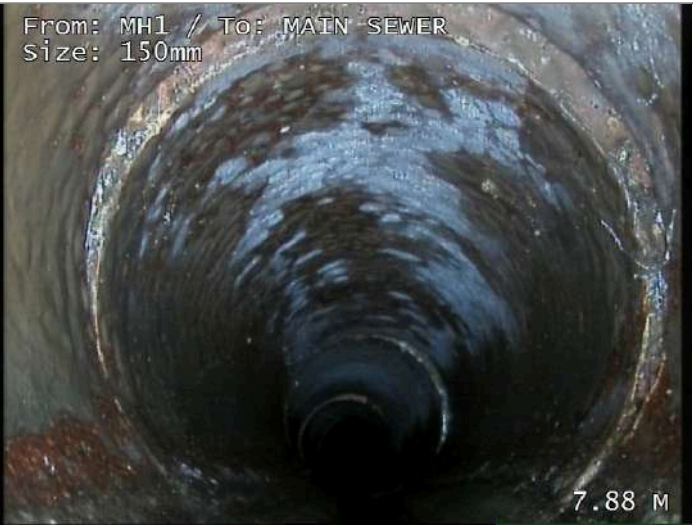
| Job Number<br><b>JB010XX</b> | Surveyed by (Operator)<br><b>TG/CM</b> | Base Unit<br><b>CAMERA UNIT</b> | Date<br><b>17/03/2026</b> |
|---|---|---|---|
| <div> <div> From: MH1 / To: MAIN SEWER<br/>Size: 150mm </div> 7.88 M </div> <div>Joint displaced 15mm</div> | | | |

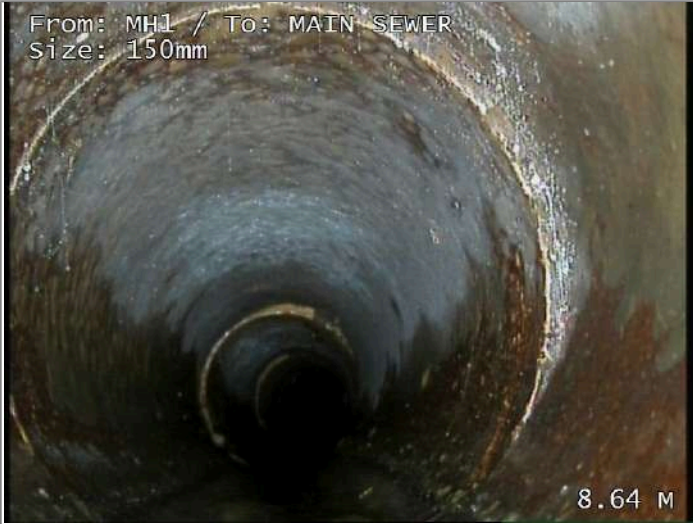
| Job Number<br><b>JB010XX</b> | Surveyed by (Operator)<br><b>TG/CM</b> | Base Unit<br><b>CAMERA UNIT</b> | Date<br><b>17/03/2026</b> |
|---|---|---|---|
| <div> <div> From: MH1 / To: MAIN SEWER<br/>Size: 150mm </div> 8.64 M </div> <div>Joint displaced 15mm</div> | | | |

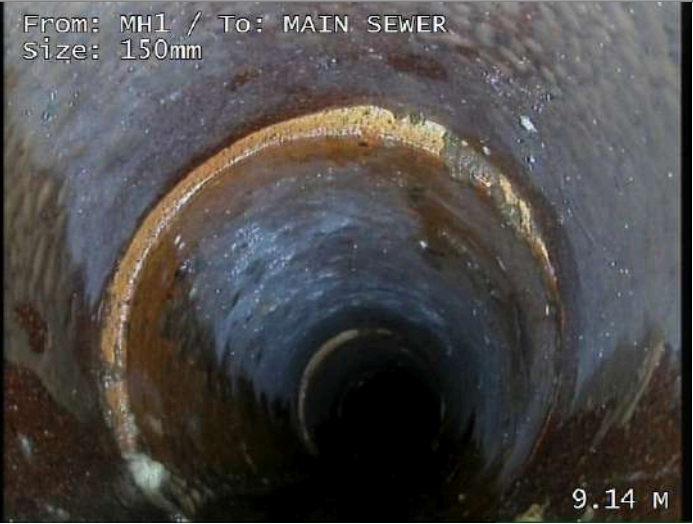
| Job Number<br><b>JB010XX</b> | Surveyed by (Operator)<br><b>TG/CM</b> | Base Unit<br><b>CAMERA UNIT</b> | Date<br><b>17/03/2026</b> |
|---|---|---|---|
| <div> <div> From: MH1 / To: MAIN SEWER<br/>Size: 150mm </div> 9.14 M </div> <div>Joint displaced 15mm</div> | | | |

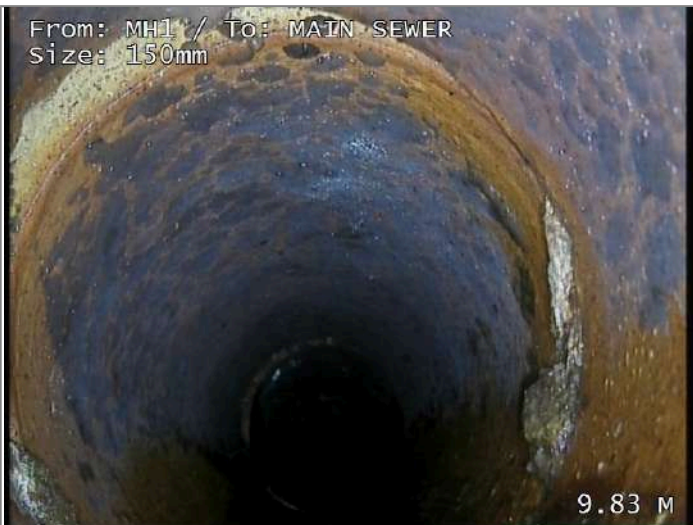
| Job Number<br><b>JB010XX</b> | Surveyed by (Operator)<br><b>TG/CM</b> | Base Unit<br><b>CAMERA UNIT</b> | Date<br><b>17/03/2026</b> |
|---|---|---|---|
| <div> <div> From: MH1 / To: MAIN SEWER<br/>Size: 150mm </div> 9.83 M </div> <div>Joint displaced 15mm</div> | | | |

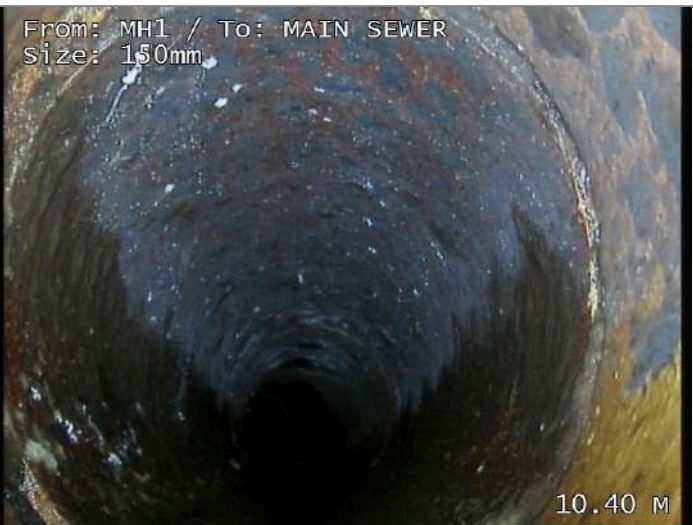
| Job Number<br><b>JB010XX</b> | Surveyed by (Operator)<br><b>TG/CM</b> | Base Unit<br><b>CAMERA UNIT</b> | Date<br><b>17/03/2026</b> |
|---|---|---|---|
| <div> <div> From: MH1 / To: MAIN SEWER<br/>Size: 150mm </div> 10.40 M </div> <div>Joint displaced 15mm</div> | | | |

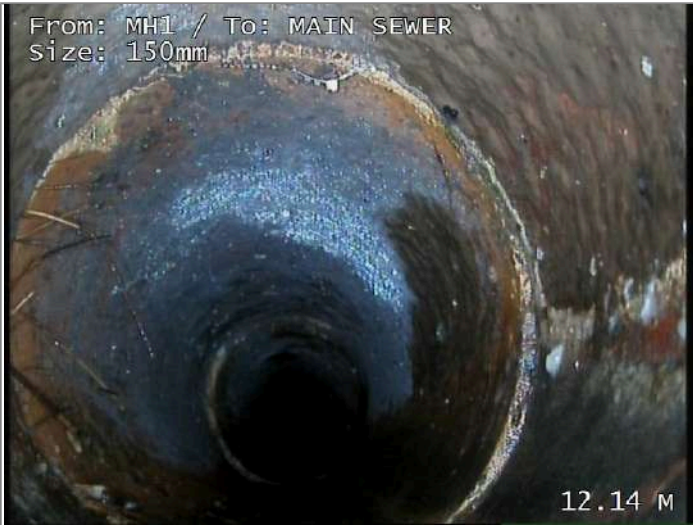
| Position | Code | Description | Photo | Type/Grade |
|---|---|---|---|---|
| 12.14 | RFJ | Roots fine, at joint | 14440435 | Service / 2 |

| Job Number<br><b>JB010XX</b> | Surveyed by (Operator)<br><b>TG/CM</b> | Base Unit<br><b>CAMERA UNIT</b> | Date<br><b>17/03/2026</b> |
|---|---|---|---|
| <div> <div> From: MH1 / To: MAIN SEWER<br/>Size: 150mm </div> <div>12.14 M</div> </div> <div>Roots fine, at joint</div> | | | |

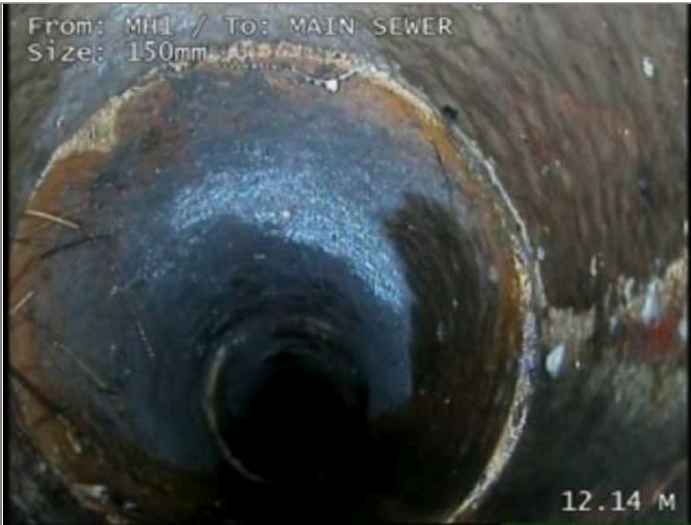
| Position | Code | Description | Photo | Type/Grade |
|---|---|---|---|---|
| 12.14 | JD | Joint displaced 5mm | 14487239 | Structural / 1 |

| Job Number<br><b>JB010XX</b> | Surveyed by (Operator)<br><b>TG/CM</b> | Base Unit<br><b>CAMERA UNIT</b> | Date<br><b>17/03/2026</b> |
|---|---|---|---|
| <div> <div> From: MH1 / To: MAIN SEWER<br/>Size: 150mm </div> <div>12.14 M</div> </div> <div>Joint displaced 5mm</div> | | | |

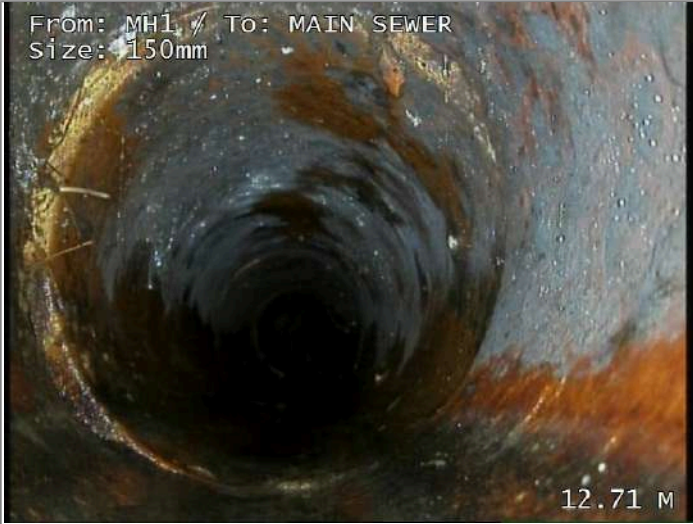
| Job Number<br><b>JB010XX</b> | Surveyed by (Operator)<br><b>TG/CM</b> | Base Unit<br><b>CAMERA UNIT</b> | Date<br><b>17/03/2026</b> |
|---|---|---|---|
| <div> <div> From: MH1 / To: MAIN SEWER<br/>Size: 150mm </div> <div>12.71 M</div> </div> <div>Joint displaced 15mm</div> | | | |

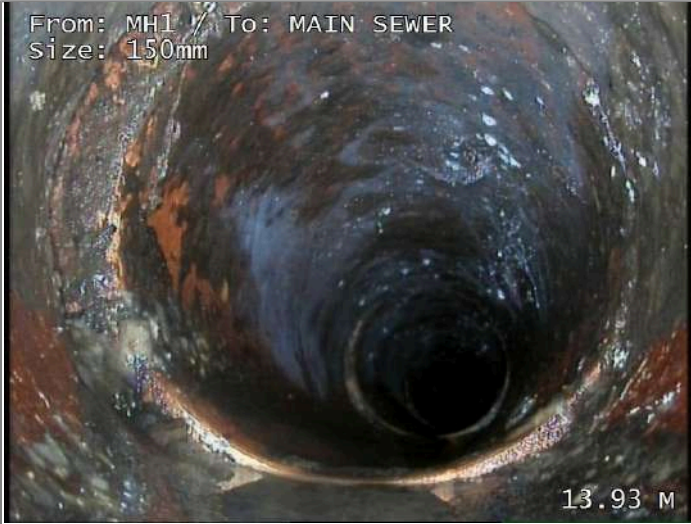
| Job Number<br><b>JB010XX</b> | Surveyed by (Operator)<br><b>TG/CM</b> | Base Unit<br><b>CAMERA UNIT</b> | Date<br><b>17/03/2026</b> |
|---|---|---|---|
| <div> <div> From: MH1 / To: MAIN SEWER<br/>Size: 150mm </div> <div>13.93 M</div> </div> <div>Joint displaced 15mm</div> | | | |

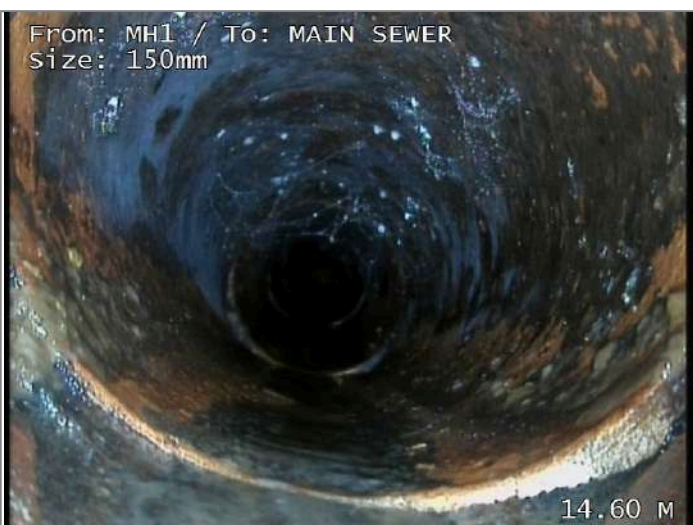
| Job Number<br><b>JB010XX</b> | Surveyed by (Operator)<br><b>TG/CM</b> | Base Unit<br><b>CAMERA UNIT</b> | Date<br><b>17/03/2026</b> |
|---|---|---|---|
| <div> <div> From: MH1 / To: MAIN SEWER<br/>Size: 150mm </div> <div>14.60 M</div> </div> <div>Joint displaced 15mm</div> | | | |

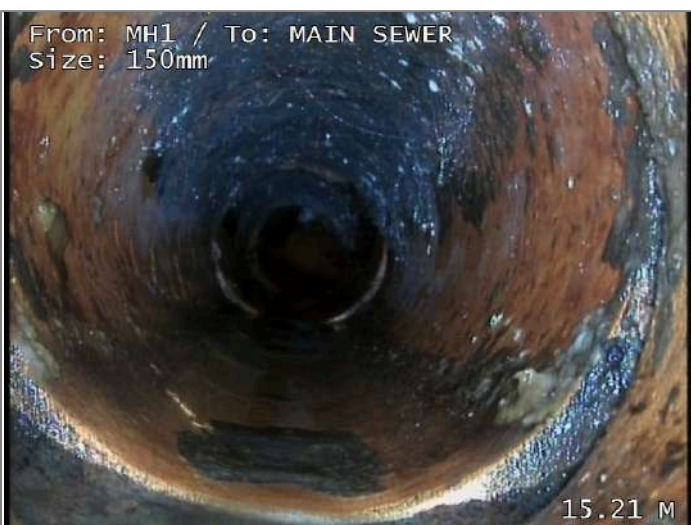
| Job Number<br><b>JB010XX</b> | Surveyed by (Operator)<br><b>TG/CM</b> | Base Unit<br><b>CAMERA UNIT</b> | Date<br><b>17/03/2026</b> |
|---|---|---|---|
| <div> <div> From: MH1 / To: MAIN SEWER<br/>Size: 150mm </div> <div>15.21 M</div> </div> <div>Joint displaced 15mm</div> | | | |

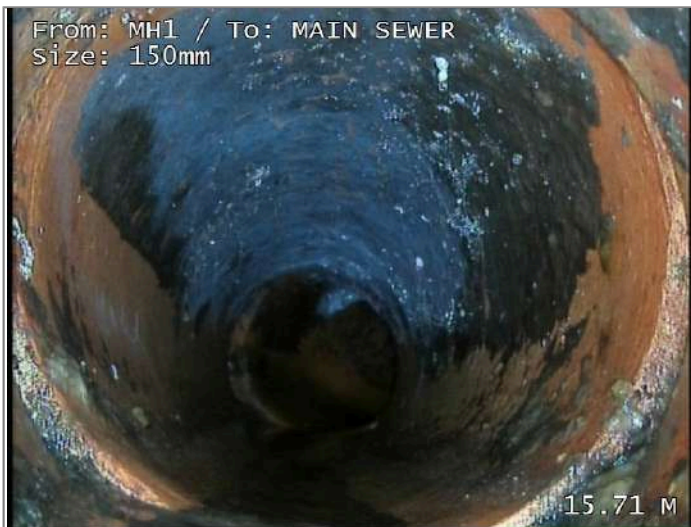
Joint displaced 15mm

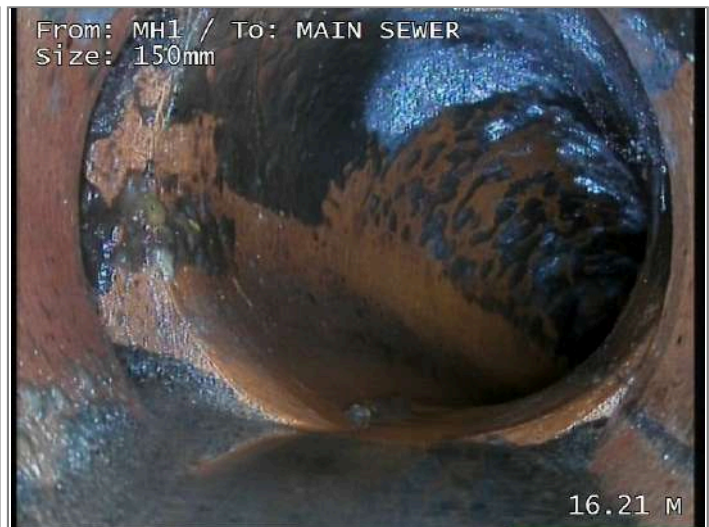
Joint displaced 15mm
