# DRAIN 247

## CCTV Inspection Report

44 Clarendon Road

### **CONDITION SURVEY REPORT**

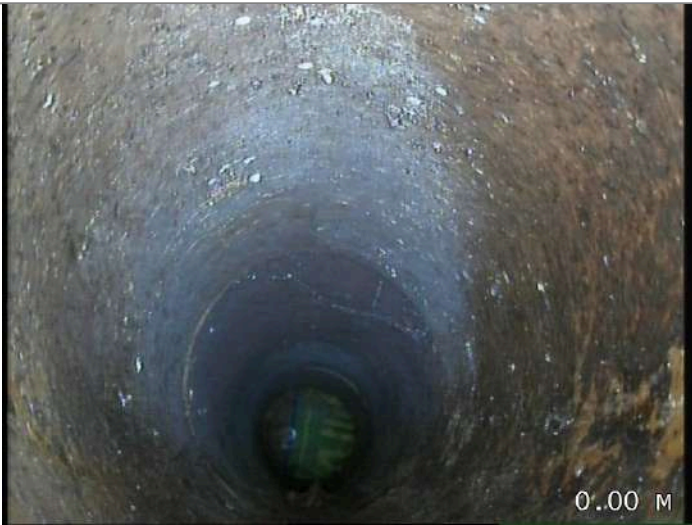
| Job Number<br><b>JB010XX</b> | Surveyed by (Operator)<br>TG/CM | Base Unit<br><b>CAMERA UNIT</b> | Date<br>17/03/2026 |
|---|---|---|---|
| <p>0.00 M</p> <p>Start node type, manhole, reference MH1</p> | | | |

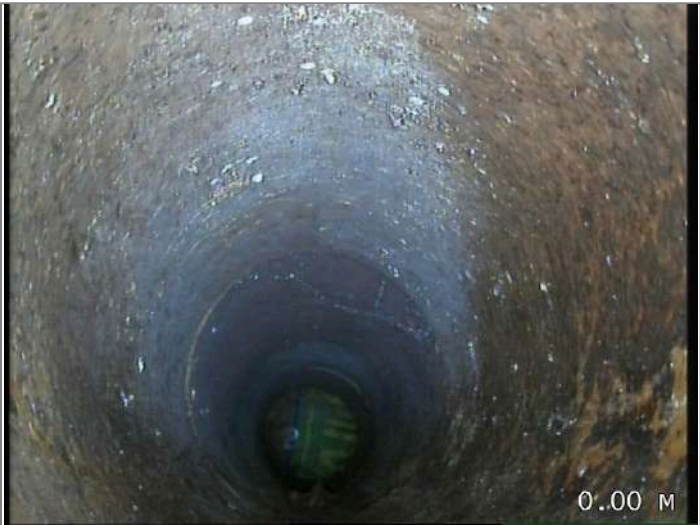
| Job Number<br><b>JB010XX</b> | Surveyed by (Operator)<br>TG/CM | Base Unit<br><b>CAMERA UNIT</b> | Date<br>17/03/2026 |
|---|---|---|---|
| <p>0.00 M</p> <p>Water level 0% height/diameter</p> | | | |

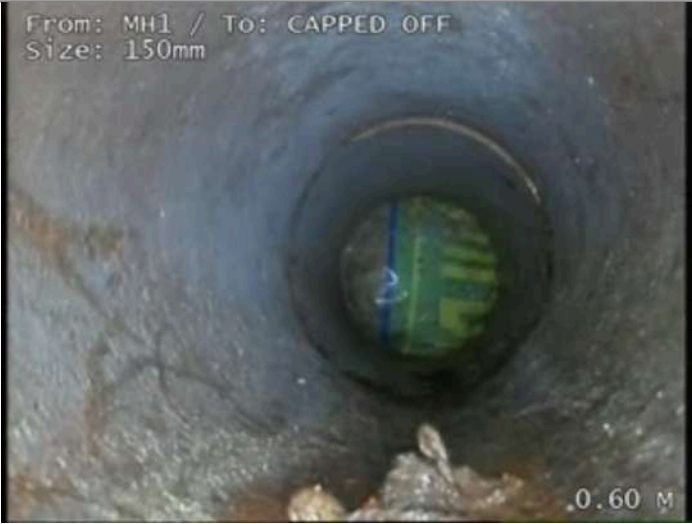
| Job Number<br><b>JB010XX</b> | Surveyed by (Operator)<br>TG/CM | Base Unit<br><b>CAMERA UNIT</b> | Date<br>17/03/2026 |
|---|---|---|---|
| <p>From: MH1 / To: CAPPED OFF<br/>Size: 150mm</p> <p>0.60 M</p> <p>LINE CLEAR</p> | | | |

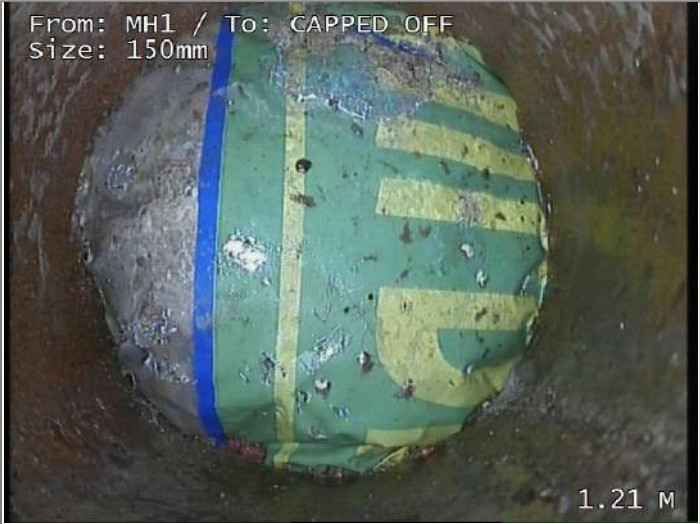
| Job Number<br><b>JB010XX</b> | Surveyed by (Operator)<br>TG/CM | Base Unit<br><b>CAMERA UNIT</b> | Date<br>17/03/2026 |
|---|---|---|---|
| <p>From: MH1 / To: CAPPED OFF<br/>Size: 150mm</p> <p>1.21 M</p> <p>Survey abandoned - Remark: CAPPED OFF</p> | | | |

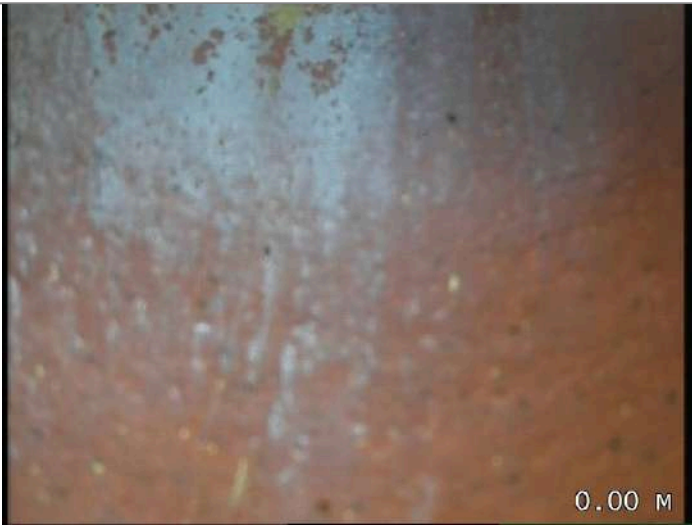
| Job Number<br><b>JB010XX</b> | Surveyed by (Operator)<br>TG/CM | Base Unit<br><b>CAMERA UNIT</b> | Date<br>17/03/2026 |
|---|---|---|---|
| <p>Start node type, manhole, reference MH1-BC1</p> | | <p>Water level 0% height/diameter</p> | |

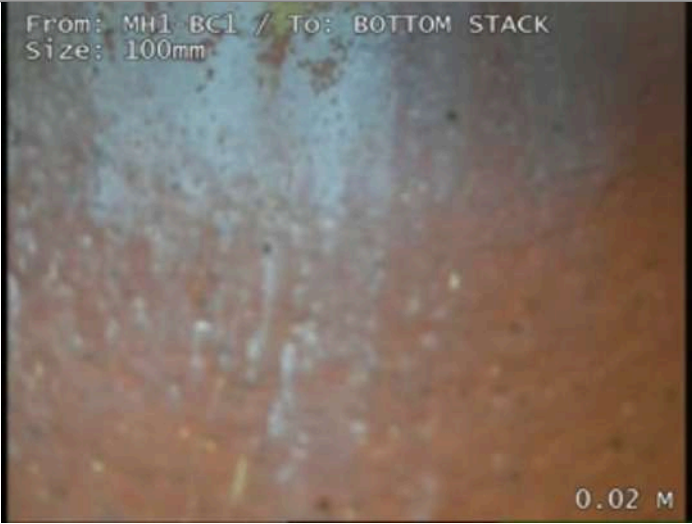
| Job Number<br><b>JB010XX</b> | Surveyed by (Operator)<br>TG/CM | Base Unit<br><b>CAMERA UNIT</b> | Date<br>17/03/2026 |
|---|---|---|---|
| <p>From: MH1-BC1 / To: BOTTOM STACK<br/>Size: 100mm</p> <p>LINE CLEAR</p> | | <p>From: MH1-BC1 / To: BOTTOM STACK<br/>Size: 100mm</p> <p>Finish node type, major connection without manhole, reference BOTTOM STACK</p> | |

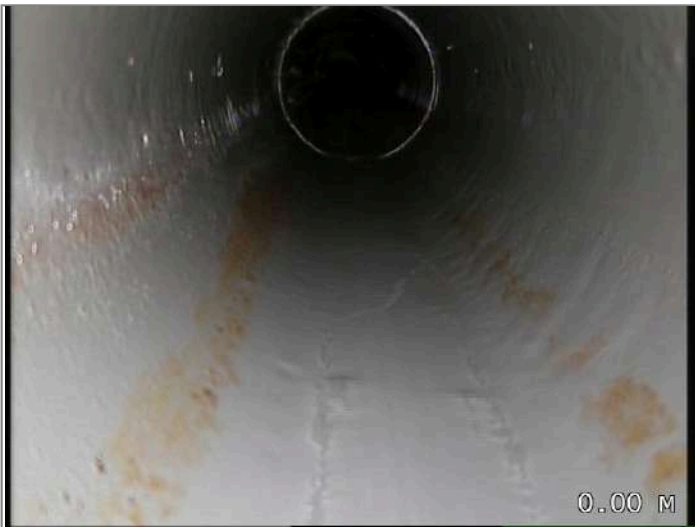
| Job Number<br><b>JB010XX</b> | Surveyed by (Operator)<br>TG/CM | Base Unit<br><b>CAMERA UNIT</b> | Date<br>17/03/2026 |
|---|---|---|---|
| <p>0.00 M</p> <p>Start node type, manhole, reference MH1-BC2</p> | | | |

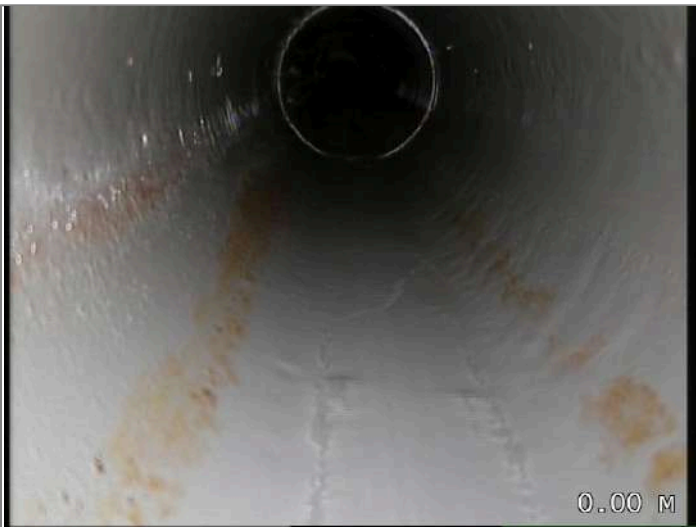
| Job Number<br><b>JB010XX</b> | Surveyed by (Operator)<br>TG/CM | Base Unit<br><b>CAMERA UNIT</b> | Date<br>17/03/2026 |
|---|---|---|---|
| <p>0.00 M</p> <p>Water level 0% height/diameter</p> | | | |

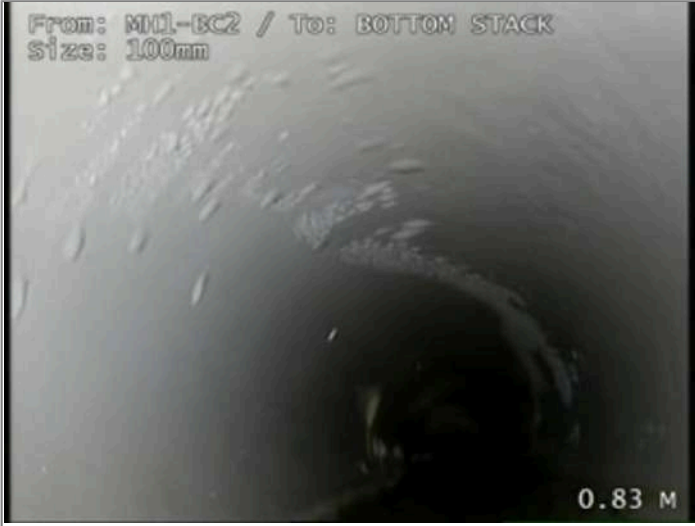
| Job Number<br><b>JB010XX</b> | Surveyed by (Operator)<br>TG/CM | Base Unit<br><b>CAMERA UNIT</b> | Date<br>17/03/2026 |
|---|---|---|---|
| <p>From: MH1-BC2 / To: BOTTOM STACK<br/>Size: 100mm</p> <p>0.83 M</p> <p>LINE CLEAR</p> | | | |

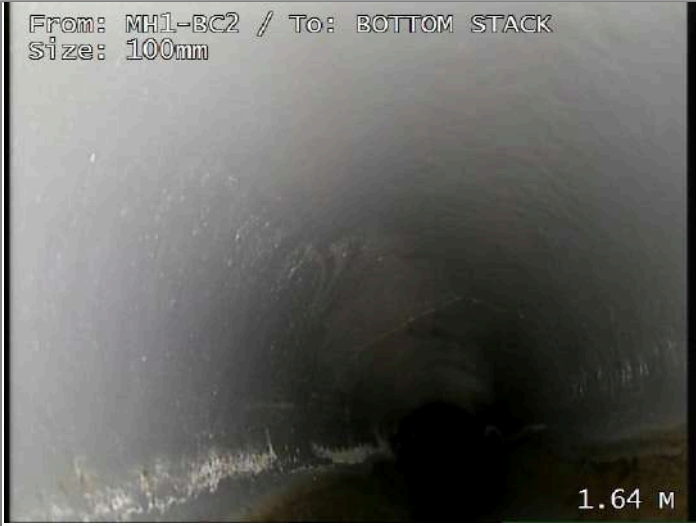
| Job Number<br><b>JB010XX</b> | Surveyed by (Operator)<br>TG/CM | Base Unit<br><b>CAMERA UNIT</b> | Date<br>17/03/2026 |
|---|---|---|---|
| <p>From: MH1-BC2 / To: BOTTOM STACK<br/>Size: 100mm</p> <p>1.64 M</p> <p>LINE CLEAR</p> | | | |

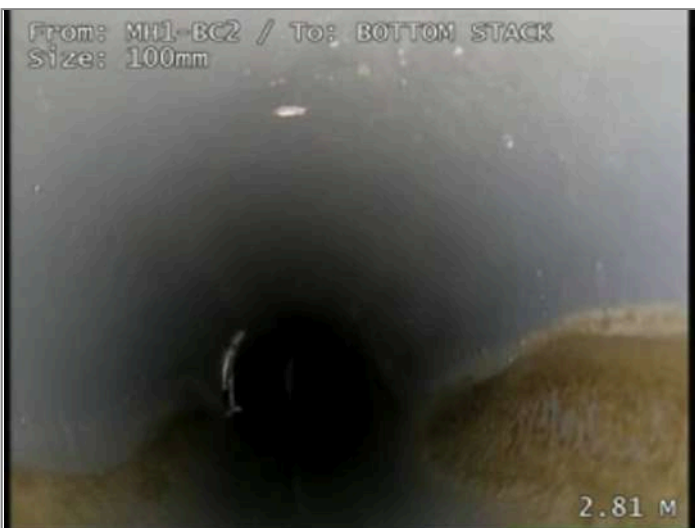
| Job Number<br><b>JB010XX</b> | Surveyed by (Operator)<br>TG/CM | Base Unit<br><b>CAMERA UNIT</b> | Date<br>17/03/2026 |
|---|---|---|---|
| <p>From: MH1-BC2 / To: BOTTOM STACK<br/>Size: 100mm</p> <p>2.81 M</p> <p>LINE CLEAR</p> | | | |

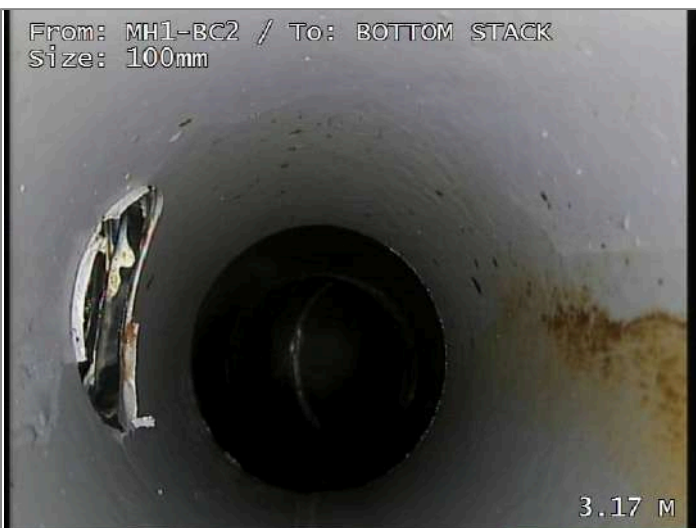
| Job Number<br><b>JB010XX</b> | Surveyed by (Operator)<br>TG/CM | Base Unit<br><b>CAMERA UNIT</b> | Date<br>17/03/2026 |
|---|---|---|---|
| <p>From: MH1-BC2 / To: BOTTOM STACK<br/>Size: 100mm</p> <p>3.17 M</p> <p>Connection other than junction at 9 o'clock, diameter 40mm</p> | | | |

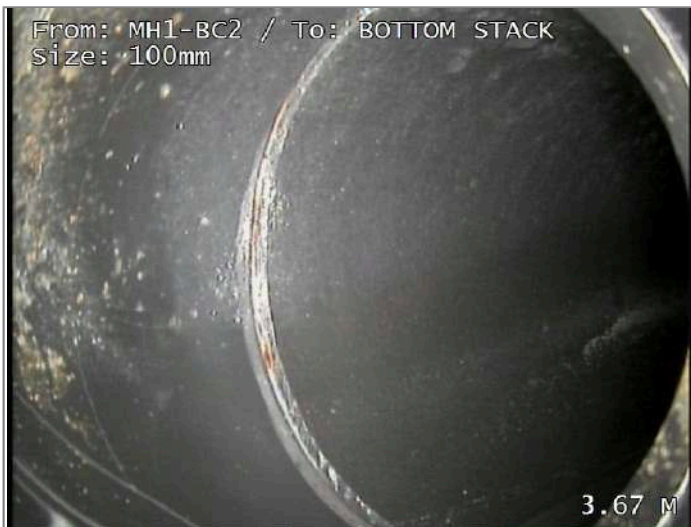
Line of drain/sewer deviates right

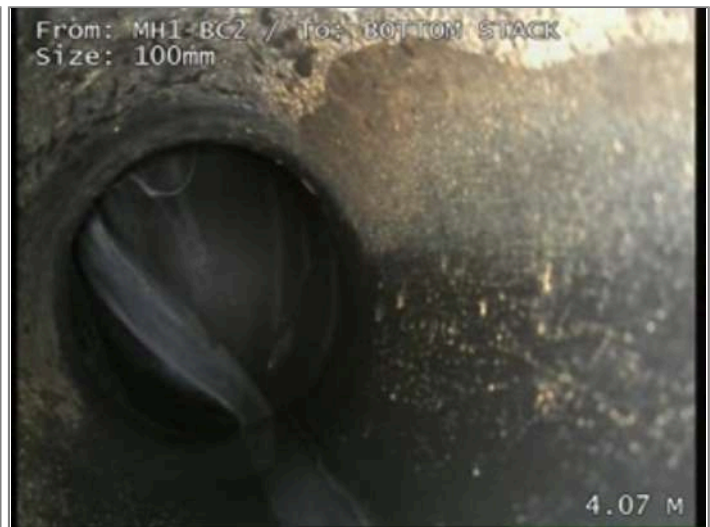
LINE CLEAR

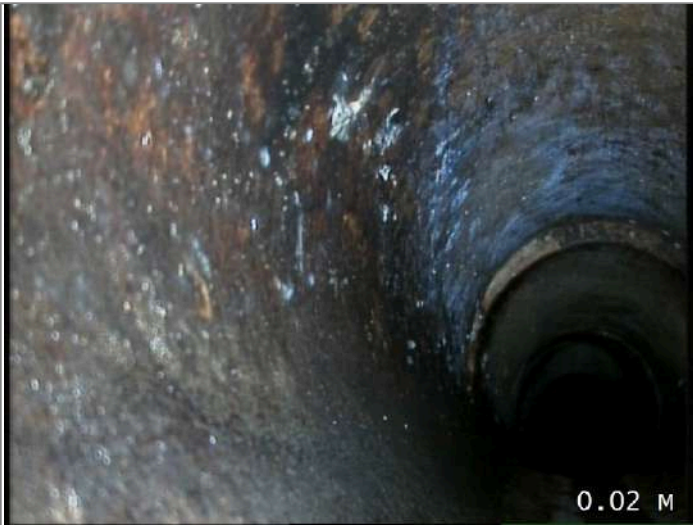
| Job Number<br><b>JB010XX</b> | Surveyed by (Operator)<br>TG/CM | Base Unit<br><b>CAMERA UNIT</b> | Date<br>17/03/2026 |
|---|---|---|---|
| <p>0.02 M</p> <p>Start node type, manhole, reference MH1</p> | | | |

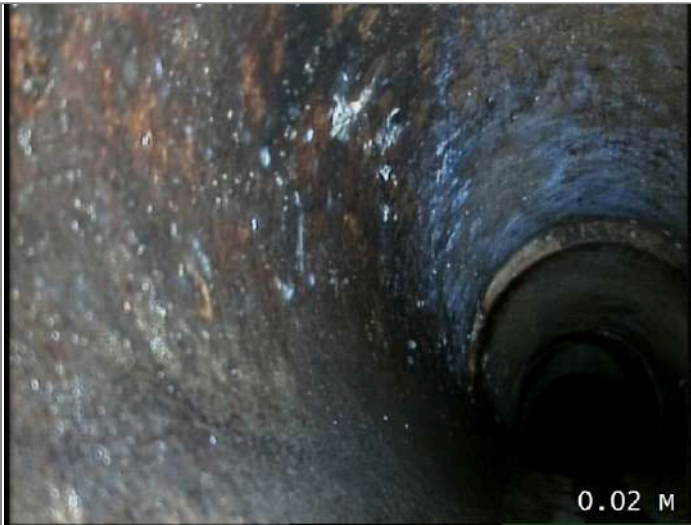
| Job Number<br><b>JB010XX</b> | Surveyed by (Operator)<br>TG/CM | Base Unit<br><b>CAMERA UNIT</b> | Date<br>17/03/2026 |
|---|---|---|---|
| <p>0.02 M</p> <p>Water level 0% height/diameter</p> | | | |

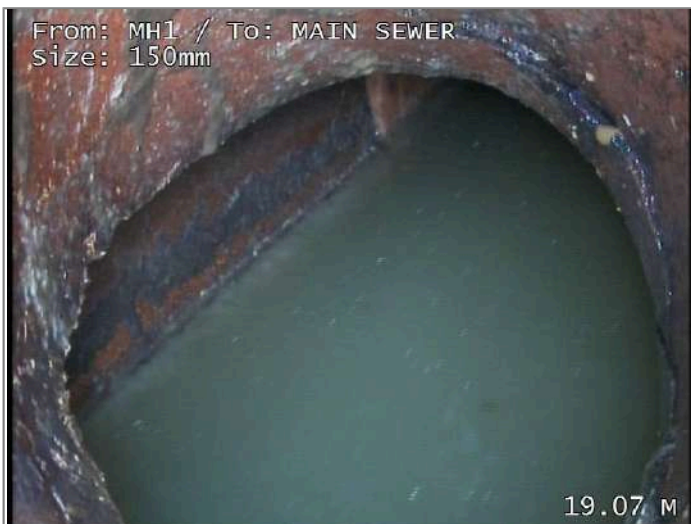
Finish node type, lamphole, reference MAIN SEWER
